Transportation Safety Board
of Canada

TRANSPORTATION SAFETY

REFLEXIONS

Issue 26 – March 2003

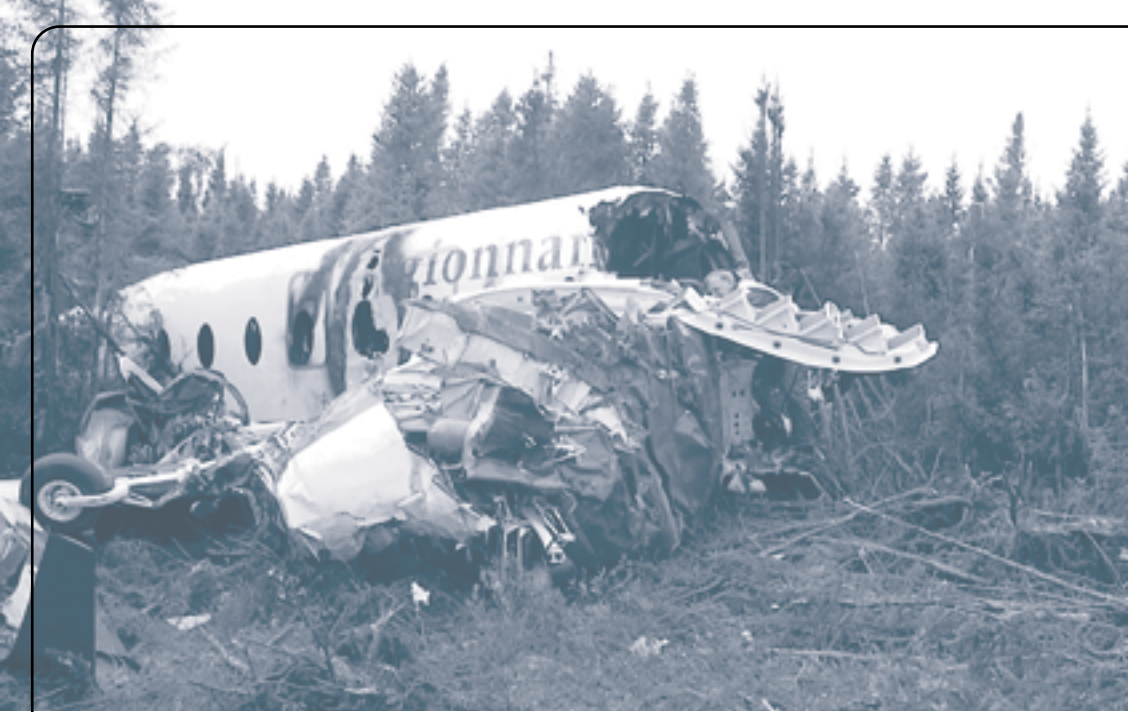
The Regionnair Raytheon Beech 1900D that crashed on approach to Sept-Îles airport in August 2002.

A post-crash fire destroyed the wings, the engines, and the right midside of the fuselage. The captain was fatally injured; the first officer was seriously injured. The first officer was wearing his three-point lap belt and his

The Department of Transport expedite the approach ban regulations prohibiting pilots from conducting approaches in visibility conditions that are not adequate for the approach to be conducted safely.

— **TSB Recommendation A02-01**

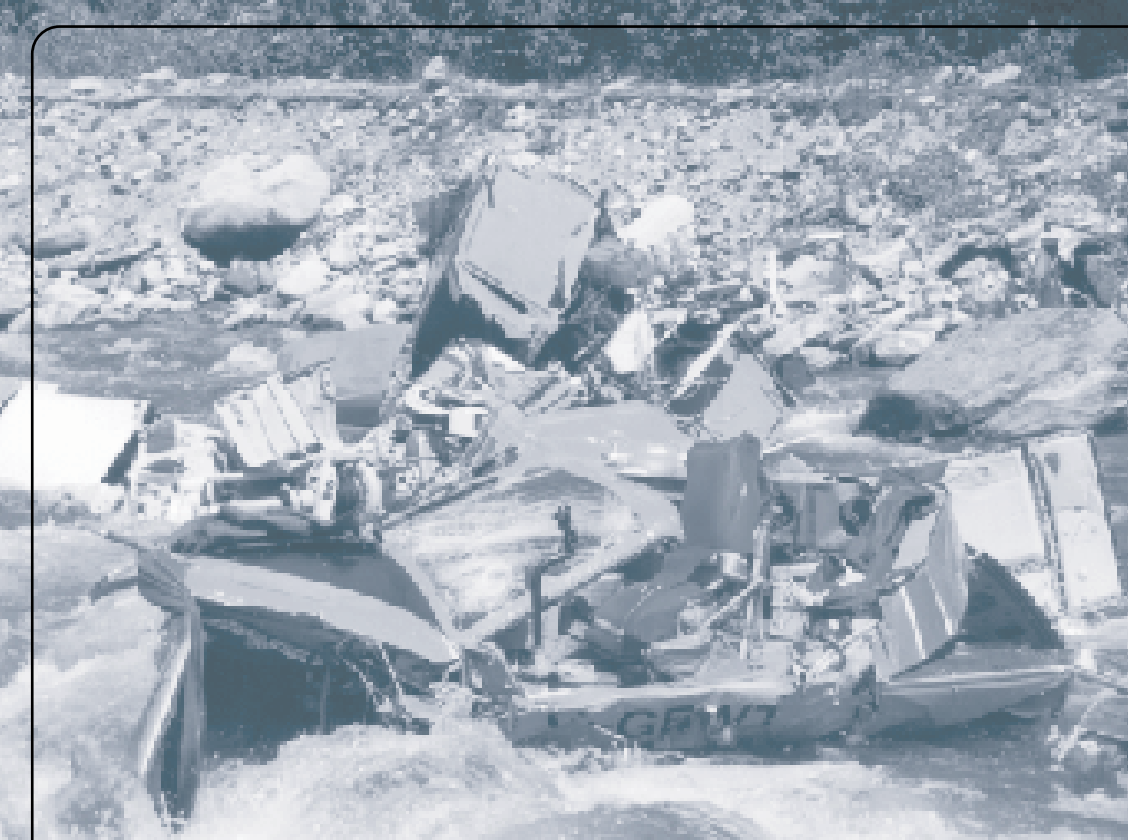
Wreckage of a Bell 214B helicopter near Kaslo, British Columbia, in July 1999.

A detailed inspection of the wreckage revealed that all component breakage and damage in the flight controls, drive train, and main-rotor gearbox were overload in nature and were attributable to the impact forces of the accident. It was determined that the helicopter engine lost power in flight (engine flame-out) because of fuel starvation.

following a power loss in the Bell 214B require timely and correct pilot response, it is possible that the pilot's lack of recent training on Bell 214B emergency procedures contributed to the unsuccessful autorotation.

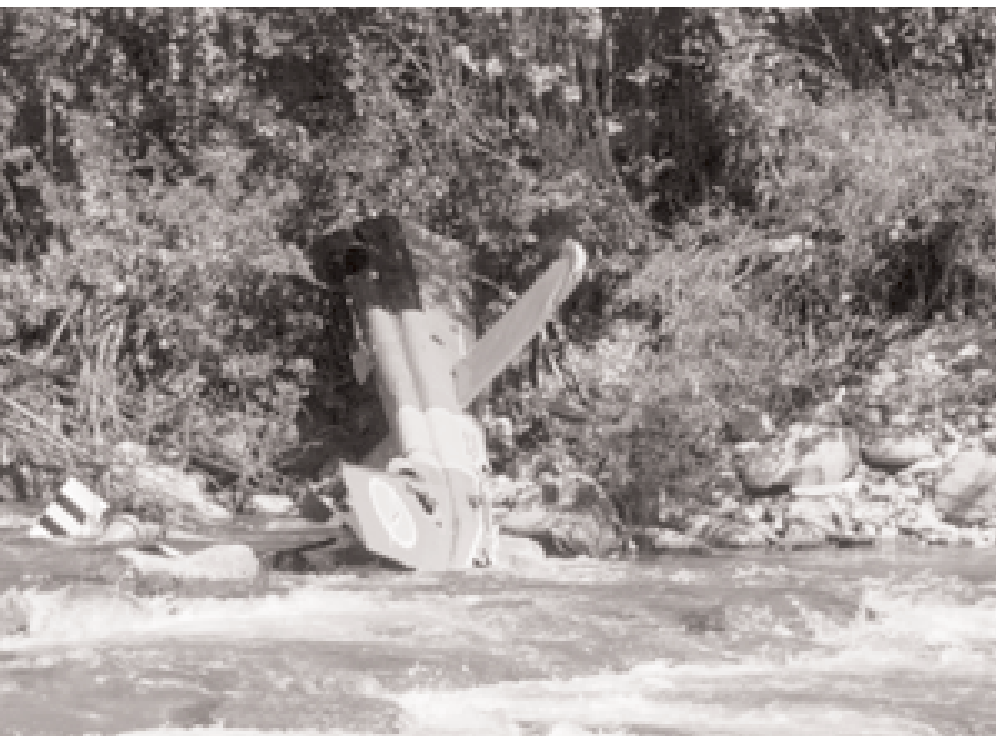
A portion of the helicopter's tail assembly.

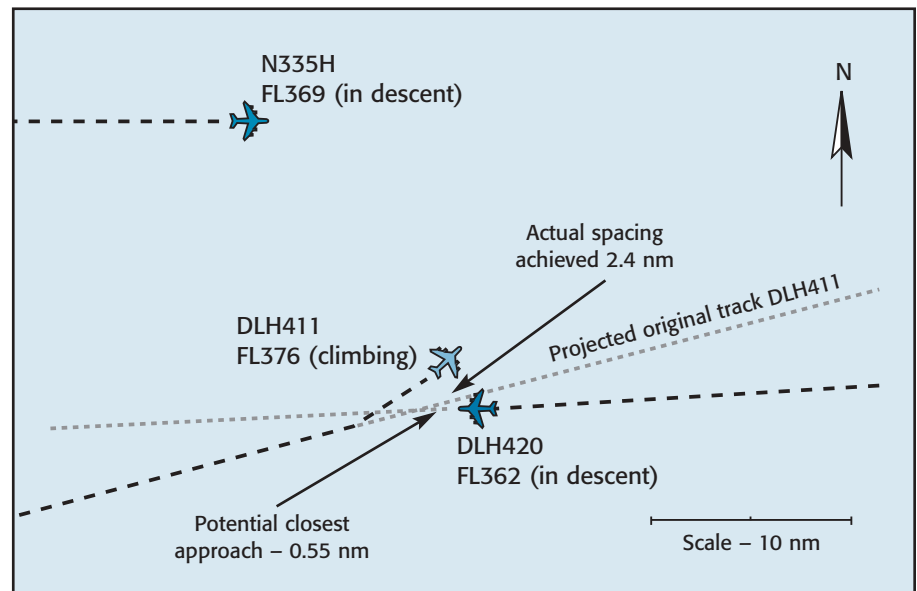
Point of closest approach.

In its final report on the investigation into this loss of separation, the Board found that there are no written requirements mandating controllers to use available handover checklists during transfer of position briefings. As a result, checklists are used only sporadically, which can lead to information being missed during the many times that handovers take place in the course of a day. Moreover, there is no standard method by which controllers depict direction of flight on the radar indicator module; this can lead to information being overlooked or misinterpreted. Gander Area Control Centre (ACC) has now included a mandatory requirement for controllers to complete the briefing checklist when assuming responsibility for a

Gander Area Control Centre (ACC) has now included a mandatory requirement for controllers to complete the briefing checklist when assuming responsibility for a sector.

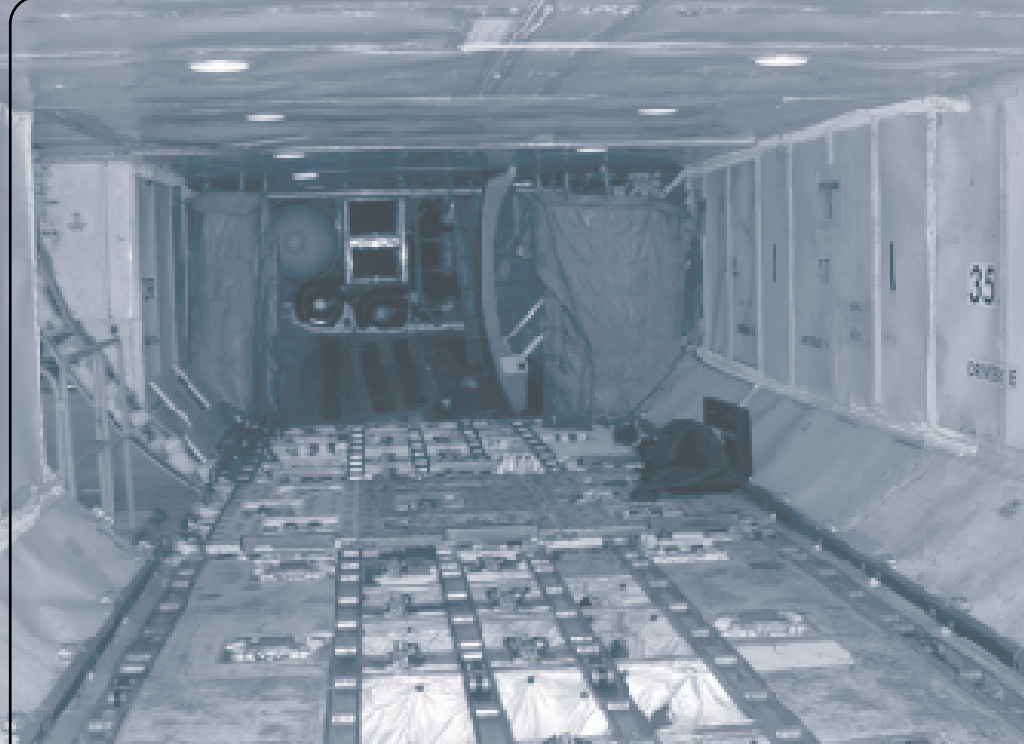
Heater ribbon failure and contaminated insulation blankets contributed to a fire in an Air Canada aircraft cargo hold such as this.

To date, the investigation has determined that a heater ribbon, used to prevent the potable water line from freezing, failed and exhibited signs of overheating and arcing. The heater ribbon, which was spiral-wrapped around the water line, burned through both the protective tape used to hold the heater ribbon in place and the foam thermal insulation material wrapped on top of the protective tape, igniting the non-metalized covering (Mylar®) of the thermal acoustic-insulation blanket mounted on the vertical web of the floor beam. The fire then spread to the insulation blanket covering on the bottom of the pressurized

Although the exact failure mechanism of the heater ribbon on the occurrence aircraft is still under investigation, examination of other failed heater ribbons suggests that an internal short or arcing event between two of the elements occurred.

The Department of Transport take action to reduce the short term risk and eliminate the long term risk, of heater ribbon installation failures starting fires, and coordinate and encourage a similar response from other appropriate regulatory authorities.

— TSB Recommendation A02-04

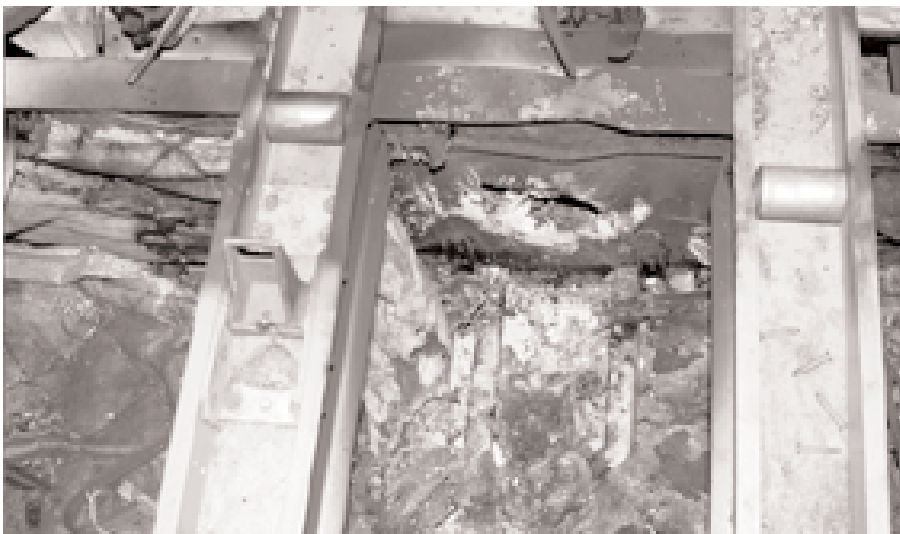
hull and ignited debris in the non-fully enclosed floor area of the aft cargo compartment. The fire became self-propagating, burning its way forward, inboard and outboard, spreading approximately 46 centimetres (18 inches) up the right-side wall of the aircraft before it was extinguished by halon from the fire extinguishing system. Heat from the fire was intense enough to burn holes through the aluminum web of a floor beam and significantly distort the top cap (chord) of the beam structure.

Fire damage caused by a faulty water-line ribbon heater. Note the heat-induced distortion to the beam structure.

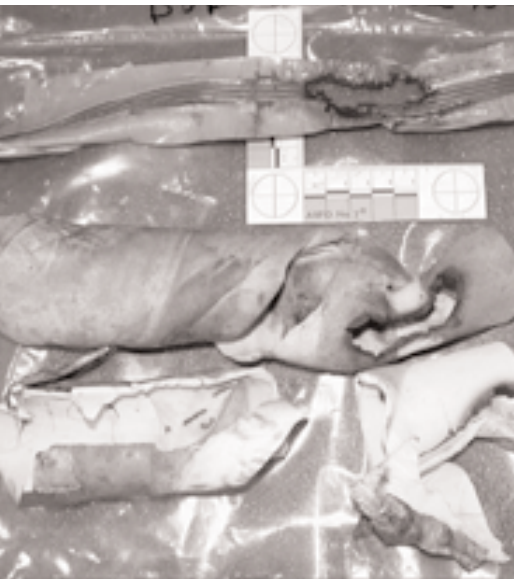
Contaminated thermal-insulation blankets such as these pose considerable fire hazards.

During inspection of the occurrence aircraft and other 767 aircraft, TSB found contaminated insulation blankets and debris in all cargo compartments with open floors. Also, a considerable amount of blanket contamination, in the form of dust, dirt and lint, was found under and behind panels in areas that are not readily accessible without the removal of panels. Subsequent to the occurrence, Air Canada examined the open forward and aft cargo areas of its 767 aircraft. A general clean-up of debris found in these areas was carried out; however, this action did not address the contaminated blankets.

The Department of Transport take action to reduce the short term risk and eliminate the long-term risk of contaminated insulation materials and debris propagating fires, and coordinate and encourage a similar response from other appropriate regulatory authorities.

— TSB Recommendation A02-05

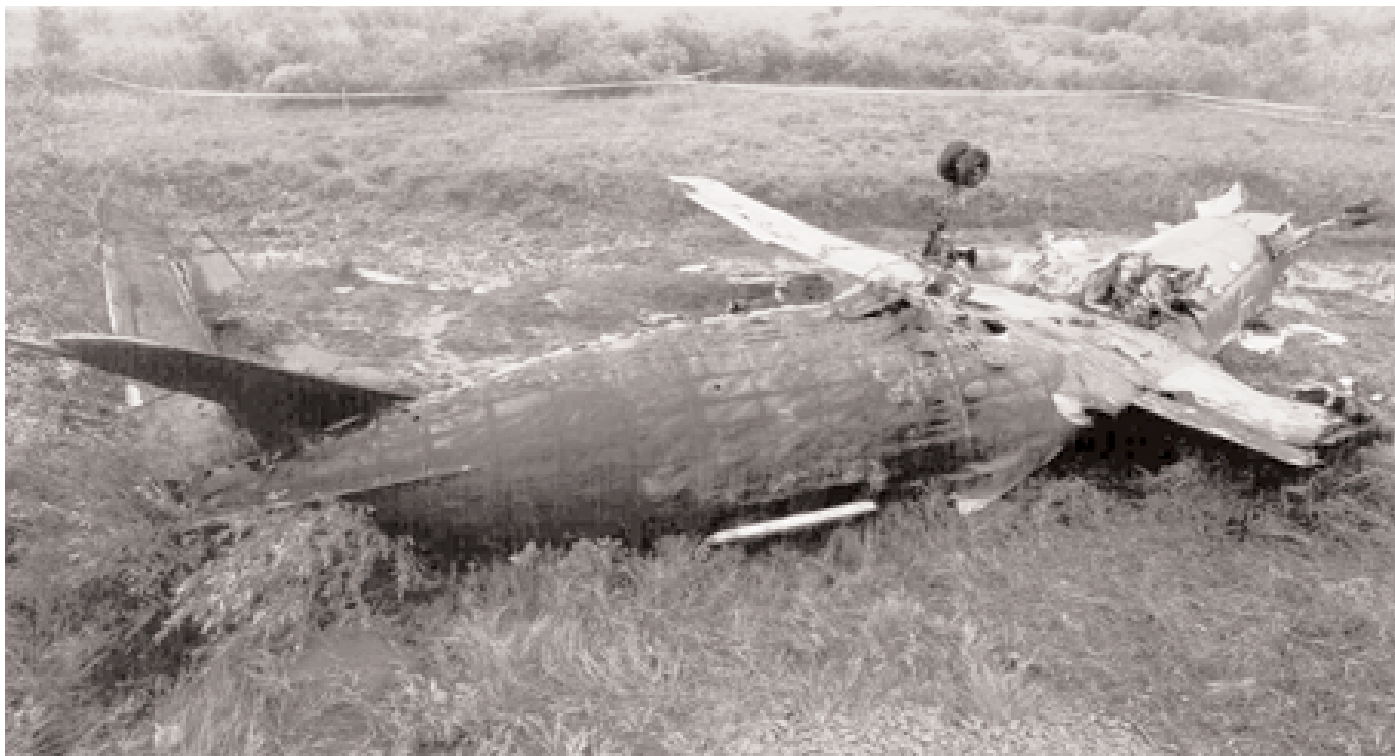
however, before the crew initiated the checklist procedures, the light went out. The light very likely went out because the fire in the wheel well destroyed the warning system electrical circuit. The TSB found that dragging of the left brakes was most probably caused by an unidentified pressure-locking factor upstream of the brakes on take-off. The dragging caused overheating and leakage, probably at one of the piston seals that retain the brake's hydraulic fluid. When hydraulic fluid leaked onto the hot brake components, the fluid caught fire and initiated an intense fire in the left nacelle, leading to failure of both hydraulic systems and eventual rupture of the adjacent main fuel line. The left wing was weakened by the wing/engine fire and failed just short of the landing, rendering the aircraft uncontrollable.

TSB research since 1983 has revealed that SA226s and SA227s suffer frequent landing gear and tire failures, wheel fires and loss of control on ground.

Transport Canada, the United States Federal Aviation Administration, and Fairchild explore options for SA226 and SA227 aircraft to be equipped with a brake-pressure warning indicator for each main wheel brake system.
— TSB Recommendation A02-03, issued May 2002

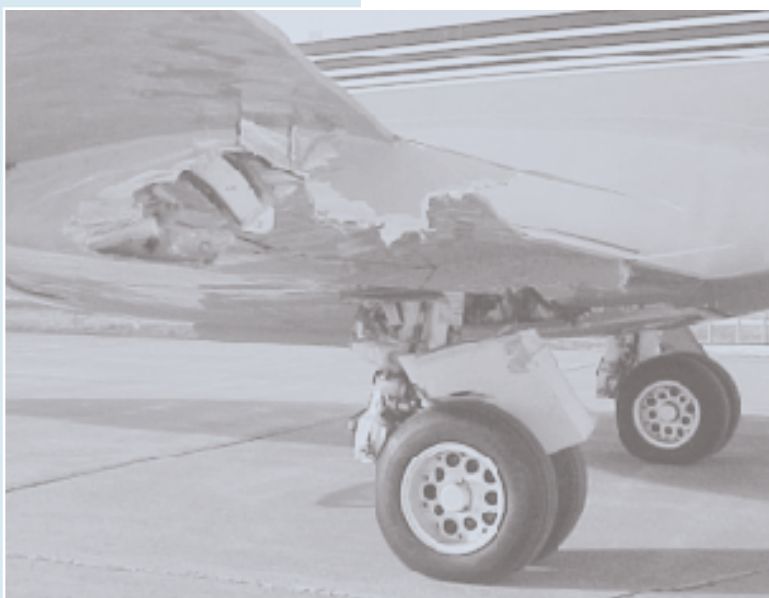
Damage to an Astra SPX, which struck treetops on approach to Fox Harbour, Nova Scotia, in March 2000.

On short final, the crew saw the tops of trees and initiated an overshoot, but not before the aircraft struck the upper branches of the trees.

During night visual approaches to runways in dark, featureless areas... the lack of ambient clues to orientation interferes with depth perception. Under these conditions, pilots often overestimate their altitude and, while concentrating on maintaining a constant visual angle of approach... (will fly along a descending) arc which results in premature contact with the ground.

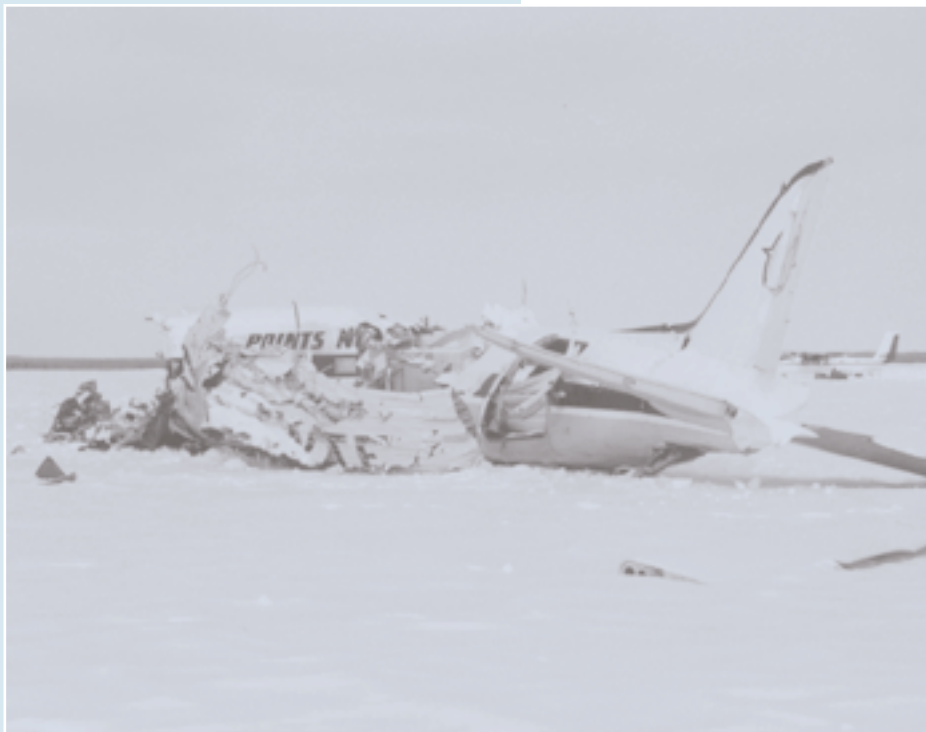
Wreckage examination did not uncover any control system or engine problem that would have led to a loss of control during the go-around; however, the basic operating weight and centre of gravity (C of G) provided in the weight-and-balance report, as submitted to Transport Canada (TC) in 1995, were found to be incorrect. That report had not been reviewed for accuracy, nor was TC required to do so. The aircraft's C of G on the accident flight was beyond the aft C-of-G limit; moreover, the stack of 2-x-4 lumber was inadequately secured and may have shifted rearward during the go-around.

Toxicological tests revealed that the levels of carbon monoxide in the blood of both crew members were elevated. A pressure-decay test was performed on the Janitrol heater; a leak was found and was determined to have existed before impact. The leak would have allowed exhaust gas to enter the cockpit environment through the heater outlets. The carbon monoxide saturation levels found in the captain likely did not affect his ability to fly and control the aircraft; however, the levels were in a range in which judgement, decision making, and visual acuity may have been adversely affected. The subsequent decisions about the positioning and securing of the 2x4s, as well as the use of the previous weight-and-balance calculation, resulted in a dangerous situation.

A combination of factors led to the crash of this Douglas DC-3 in which both pilots perished at Ennadai Lake, Nunavut, on 17 March 2000.
